OVERSIGHT SUMMARY

**USEPA/ARCS V
BVWS Oversight Summary**

Reporting Period: July 19 & Oct 2, 1995 Hours Worked: 20

Site Name/Location: ACS/Griffith, IN BVWS Project No.: 71670.660

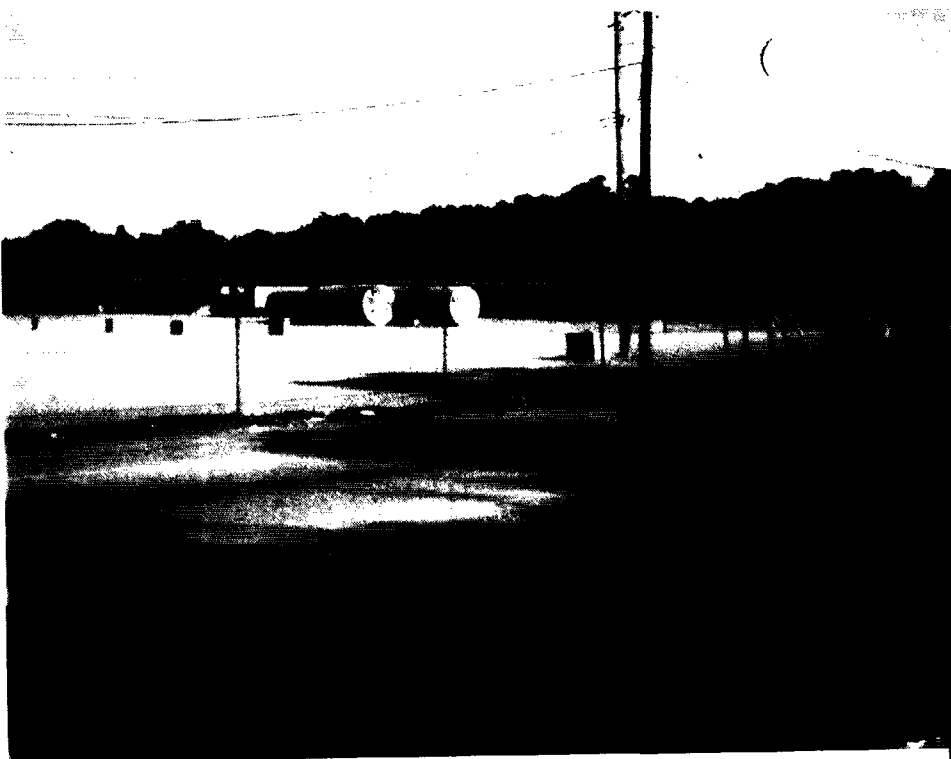
Description: Photo taken facing southwest of the central portion of the American Chemical Services, Inc. facility.

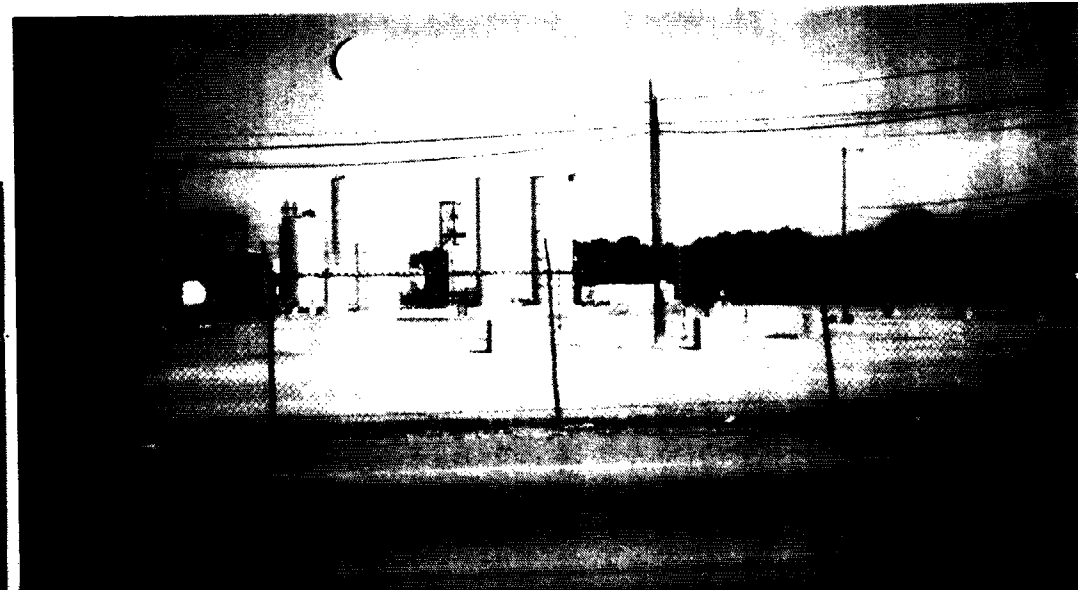
Description: Photo taken facing north of the onsite containment area of the American Chemical Services, Inc. facility. The photo is part of a panoramic view of the site. Other photos included in the panoramic photo are Photo #'s 3-7.

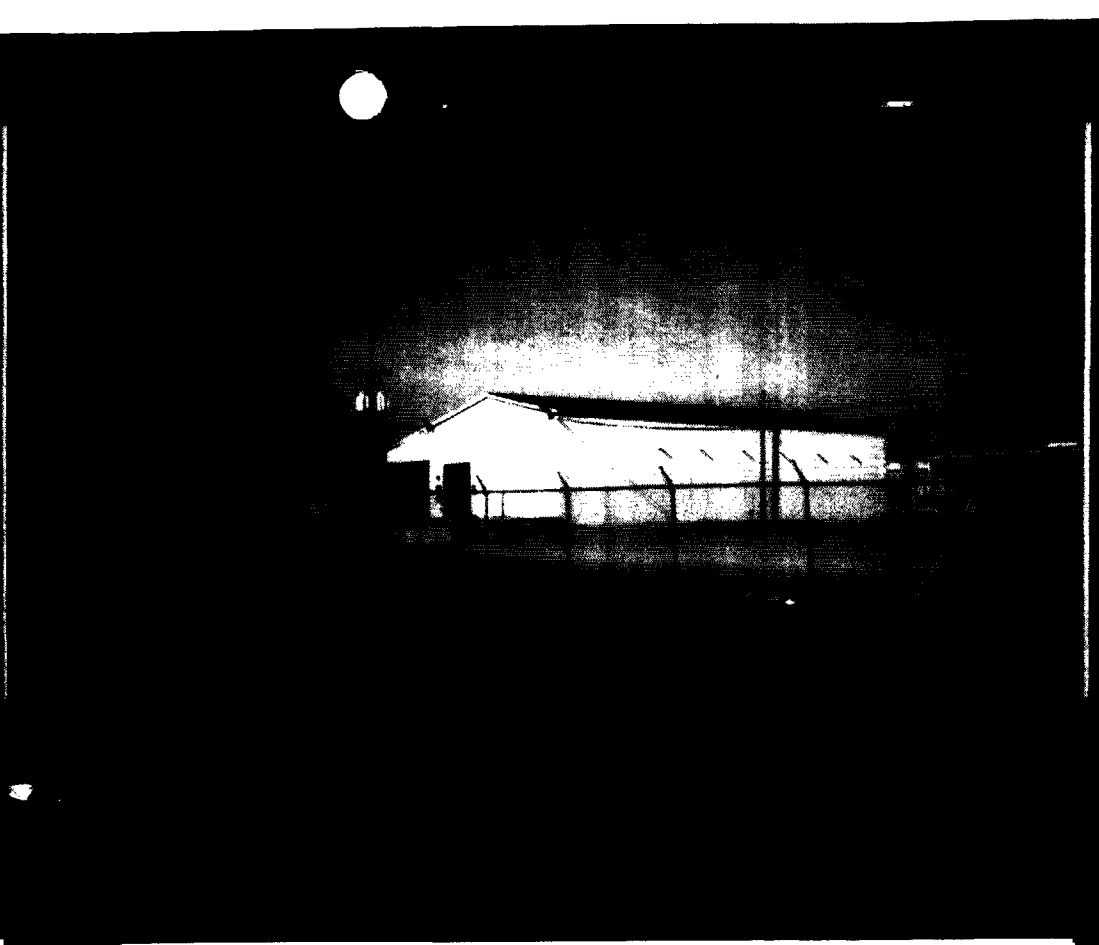
Description: Photo taken facing west of the central portion of the American Chemical Services, Inc. facility. The photo is part of a panoramic view of the site. Other photos included in the panoramic photo are Photo #'s 3-7.

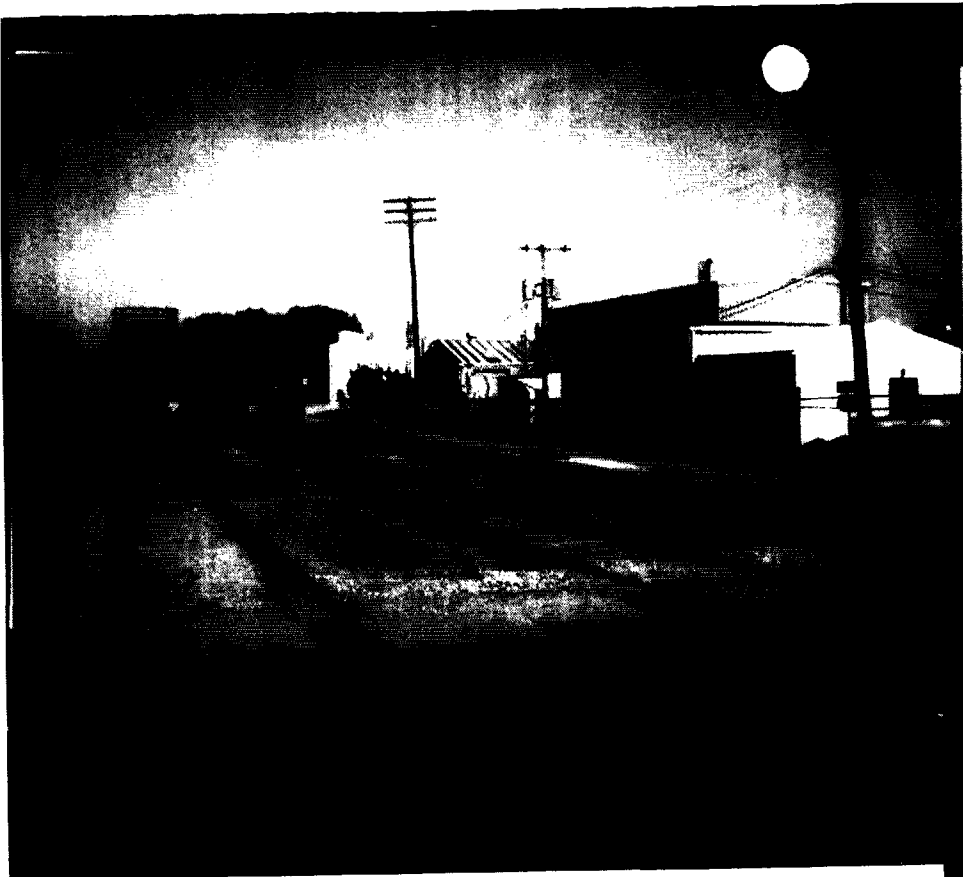
Description: Photo taken facing north of the southeastern portion of the American Chemical Services, Inc. facility. Behind the brick building at right is the Spill Bottoms area.
